**Flood Control Project Maintenance  
Levee Inspections**

**Maintenance Issue Types Only, Levee Inspection Report By Mile - Fall 2018**

**Reclamation District No. 0010 Honcut**

Waterway	Bank	Unit Miles	Inspection Start/End	Inspector
Unit No. 01 Simmerly Slough	Right	7.65	10/15/2018 10/15/2018	Sterling York

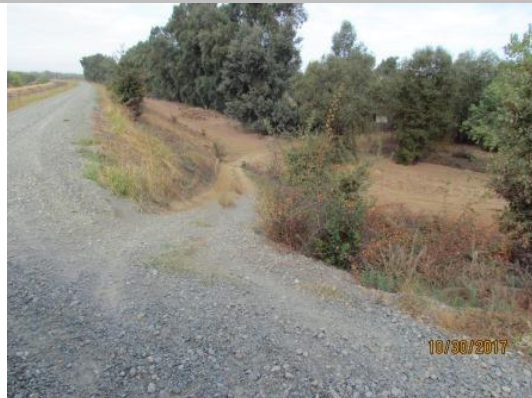
Photo 1 of 1 : FA\_2018\_RD0010\_163\_48\_20180918\_00014.jpg

LM Start	0.72	Rating **	M	Issue No.	48
LM End	0.72	Issue Type +	Ma	Location *	LS
Category	Earthen Levee			GPS Latitude/Longitude	
				Start	End
Item	Slope Stability			39.161198 °	39.161198 °
				-121.597102 °	-121.597102 °
DWR ID	DWR_RD0010_01_f_2013_48				
Comment Code					
S3 : Repair the levee slope damaged by vehicle traffic and prevent access where possible.					
Inspector Comment					
Ramp is caused by constant ATV foot traffic use on levee slope. Fall 2018.

View of the slope stability caused by foot traffic on the landward side of the levee looking downstream.

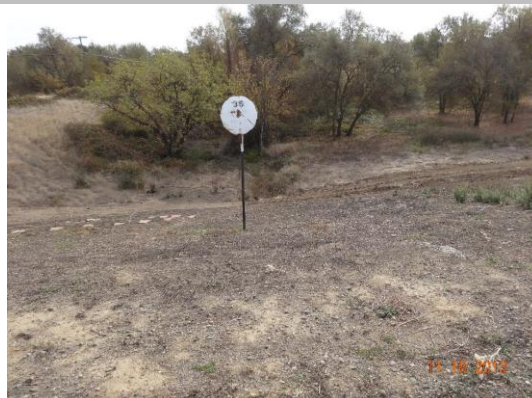
Photo 1 of 3 : UCIP\_FA\_2018\_53136\_44588.jpg

FS\_ID:53136  
DS\_ID:21318  
EP\_NO: N/A  
Repair Type: Urgent  
Crossing Status: Found  
UCIP Comments: 10/18/2018 No change since the last inspection. Pipe remains Urgent due to deteriorated wall (visible holes present inside) near WS flap gate. This pipe is part of DWR's Deferred Maintenance Project (DMP). According to LMA representative, the video inspection of DMP pipes is expected to be completed next year. Levee height is about 25-30 feet. (O. Magana - DWR UCIP)7/01/2016 Pipe wall in poor condition--deteriorated pipe wall indicated by holes at the inlet and outlet pipe collar. Recommend internal integrity inspection of the pipe through the levee to determine extent of damage. (DWR UCIP - omagana)4/29/2013 Holes present on pipe wall. Need to contact owner to notify of issue with pipe. Also need to contact DWR Inspector and CVFPB to determine how to address issue. This crossing is referenced in the USACE Periodic Inspection as item USACE\_CESPK\_HON1\_2013\_p\_0140. Pipe should be 30-inch instead of 36-inch mentioned Periodic Inspection. (DWR UCIP - omagana) FIELD\_STRUCT\_DESC: 30-inch corrugated metal gravity drainage pipe through the levee, approximately 30 feet below the crown. Two corrugated metal cutoff walls around the pipe on each side. Saddle and splash apron at the waterside (WS) discharge point. Concrete headwall and sluice gate on the landside (LS). [Additional Reference(s): DWR Levee Log, 2005. USACE Sacramento O&M Manual 151, May 1953, (Station 10+38)].

View of WS--marker present on WS shoulder.

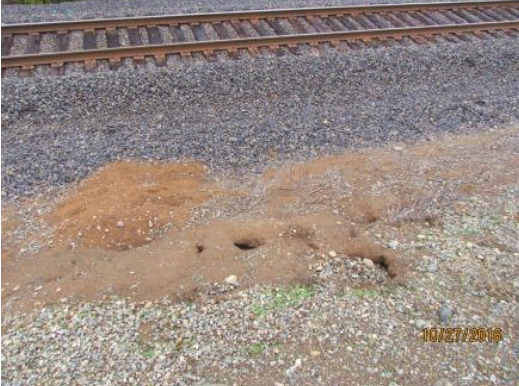
Photo 1 of 1 : FA\_2018\_RD0010\_163\_58\_20180918\_00021.jpg

View of squirrel holes on the landside slope and toe, no rodent activity was observed. Fall 2016.

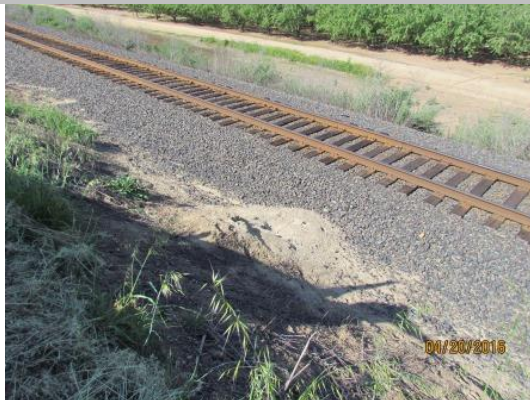
Photo 1 of 1 : FA\_2018\_RD0010\_163\_51\_20180918\_00017.jpg

View of large burrow on landside.

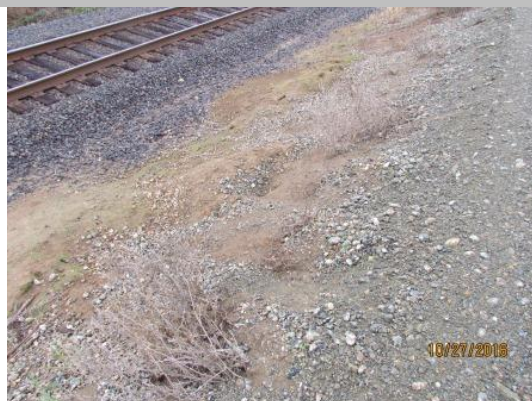
Photo 1 of 1 : FA\_2018\_RD0010\_163\_50\_20180918\_00016.jpg

View of squirrel holes on the landside slope and toe, no rodent activity was observed. Fall 2016.

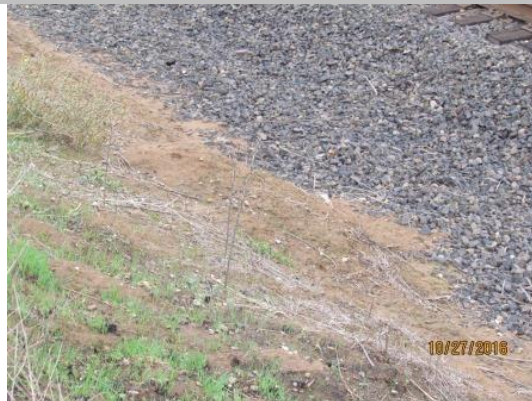
Photo 1 of 1 : FA\_2018\_RD0010\_163\_46\_20180918\_00012.jpg

View of squirrel holes on the landside slope and toe, no rodent activity was observed. Fall 2016.

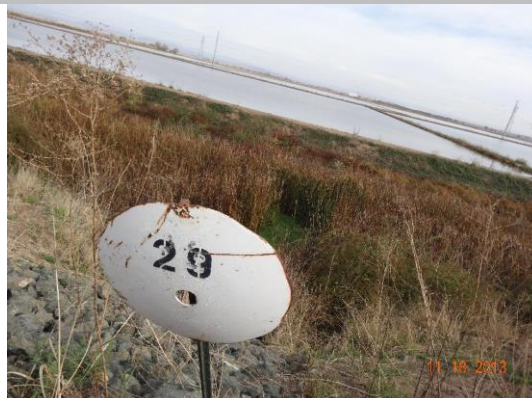
Photo 1 of 3 : UCIP\_FA\_2018\_53138\_44811.jpg

UCIP Comments: 10/18/2018 According to the LMA representative, a small pipe repair was completed near the WS gate (pipe was leaking at pipe collar). Pipe has been upgraded from Non-Urgent to Urgent due to the wall deterioration near the outlet and an unknown condition through the levee. Levee is about 20 feet high. Recommend video inspection to determine pipe condition through the levee. This pipe is part of DWR's Deferred Maintenance Project (DMP), video inspection is expected to be completed next year for this crossing. (O. Magana - DWR UCIP)7/01/2016 WS slope appears to be stable; UCIP issue has been downgraded from Urgent to Non-Urgent due to what appears to be a stable slope--no other issues were observed during the site visit. The reason for the Non-Urgent classification is due to the limited documentation available to support extent of repair--need to obtain repair records to determine extent of repair and to determine if pipe was replaced through the levee. (DWR UCIP - omagana)4/29/2013 limited access; steep slopes, and dense vegetation; New riprap has been placed along pipe alignment need to contact owner to determine work authorization. Also need to find out if the design for riprap was due to slope failure at this location. This crossing is referenced in the USACE Periodic Inspection as item USACE\_CESPK\_HON1\_2013\_p\_0246. (DWR UCIP - omagana)

Marker for pipe crossing visible on WS shoulder.

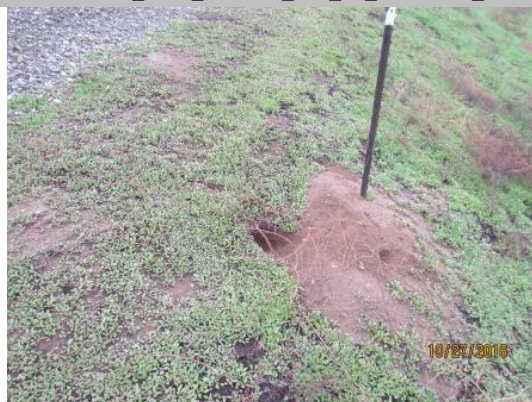
Photo 1 of 1 : FA\_2018\_RD0010\_164\_28\_20180918\_00003.jpg

View of squirrel hole on the waterside looking downstream. Fall 2016

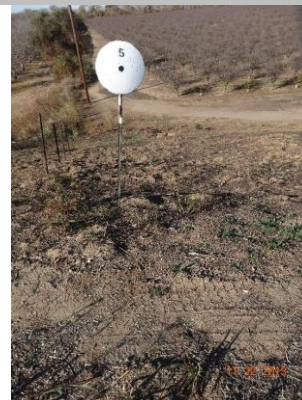
Photo 2 of 3 : UCIP\_FA\_2018\_24822\_44648.jpg

Overview of waterward slope--dense burrow activity on slope.

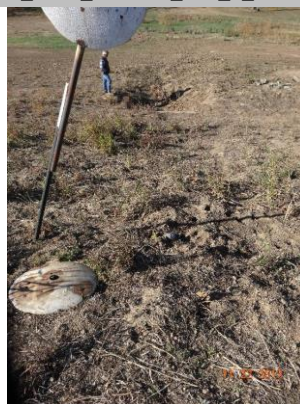
Photo 1 of 1 : FA\_2018\_RD0010\_164\_7\_20180918\_00001.jpg

View of waterward slope--burrow activity present.

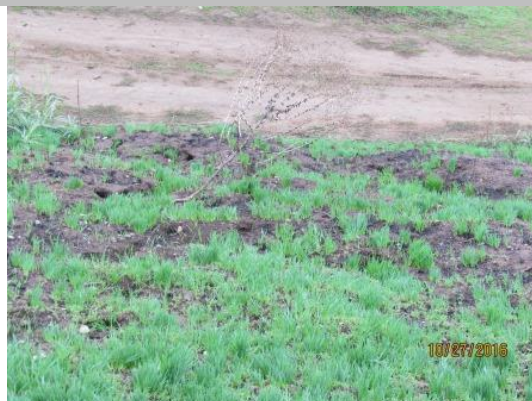
Photo 1 of 1 : FA\_2018\_RD0010\_164\_68\_20180918\_00027.jpg

View of rodent holes on waterside slope, no evidence of rodent activity Spring 2017.

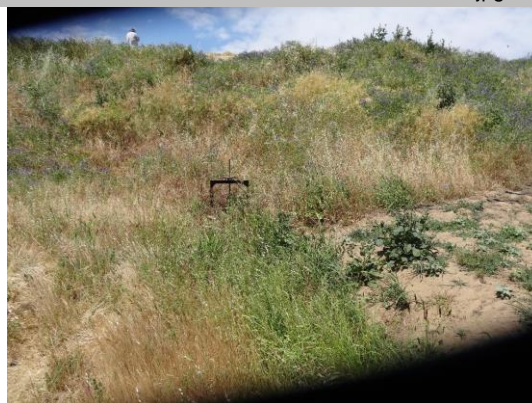
Photo 3 of 3 : UCIP\_FA\_2018\_24751\_44373.jpg

View of landward side--dense vegetation.

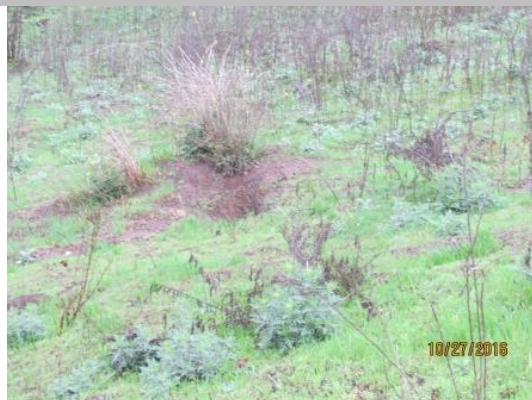
Photo 1 of 1 : FA\_2018\_RD0010\_164\_35\_20180918\_00012.jpg

View of rodent hole on waterside.

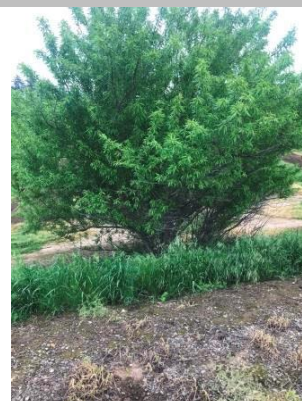
Photo 1 of 1 : FA\_2018\_RD0010\_164\_66\_20180918\_00026.jpg

View of small peach tree on the landside toe looking downstream that should be removed, Spring 2018.

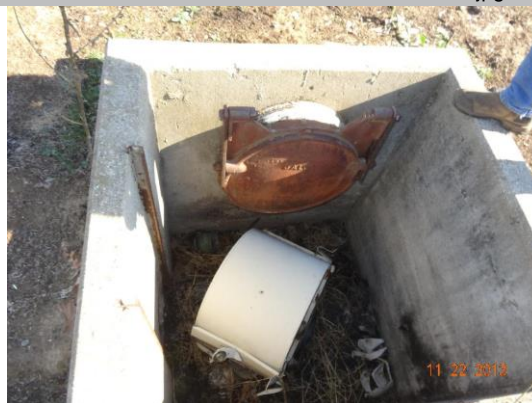
Photo 2 of 3 : UCIP\_FA\_2018\_24769\_44453.jpg

View of flap gate located inside concrete distribution box. Debris scattered inside box.

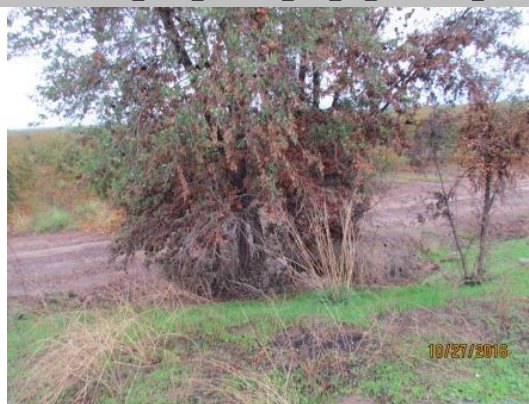
Photo 1 of 1 : FA\_2018\_RD0010\_164\_70\_20180918\_00029.jpg

View of tree on landside toe that need to be trimmed up five feet for visibility and access.
